MISSION: IT'S POSSIBLE

BY JIM AND REESE LEACH, WINDWARD AVIATION
LANTANA, FLORIDA

This story began innocently enough in December 2001 when Windward Aviation bid an annual inspection and performing SB 27-3358 to remove the speed restriction imposed on early, short-cord ruddervator Bonanzas and a Beryl D'Shannon tip tank installation on N5243C, a 1950 B35 owned by Peter Scott. Mr. Scott is a British citizen and president of Heliscott, Ltd., a helicopter company in Great Britain. The Scotts reside part of the year in Central Florida. Mr. Scott has restored older automobiles and aircraft.

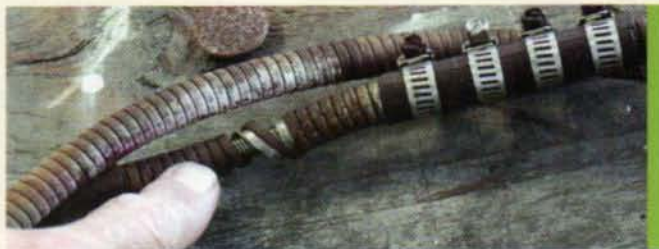
Damaged flap drive cable

The flap drives were replaced after numerous and improper repairs were discovered. These discrepancies, although not show stoppers, had to be addressed with parts from Beech, some combing of salvage yards and employing FAA-accepted repair techniques.

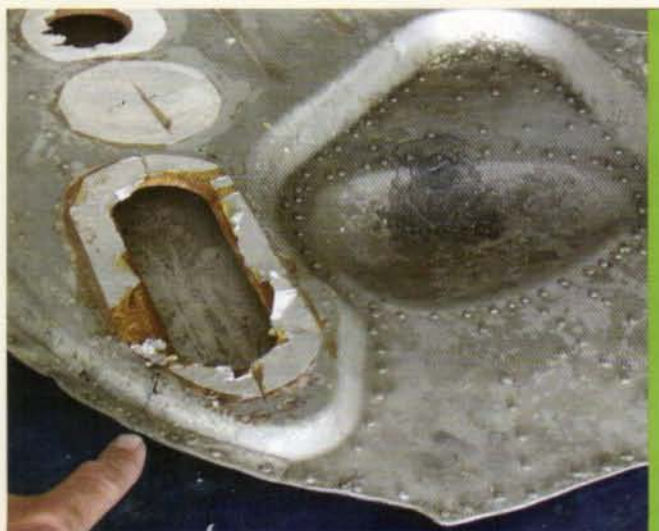
Meanwhile, the annual inspection was progressing. We discovered damage in the right wing wheel well and below the right rudder pedals where the exhaust stack, if improperly rigged, can vibrate against the fuselage and eventually wear a hole in the skin. In addition, excessive corrosion warranted

Crack in inner gear door....also intergranular corrosion has broken through. See hole in blister at center of door.

inner gear door and right engine cowling door replacement as well as repairing the baggage door.

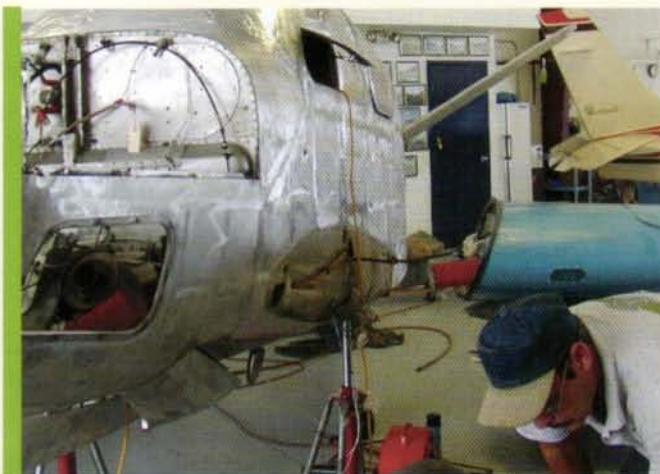
Wing mating shown in progress.

Upon providing the owner with digital photos via e-mail and reviewing our options, we concluded wing replacement was the most cost-effective approach. A wing was located at a reputable salvage yard, Dodson International, and shipped in by truck. We examined the wing and made a minor repair to the leading edge where it had been damaged during a wind storm at the salvage yard.

The wing was mounted with new bolts, washers and nuts. The landing gear was reinstalled and the pitot system made operational. The left fuel cell was overhauled by Eagle Fuel Cells and installed in the wing cavity. Minor corrections were made to the electrical wiring, fuel sender and plumbing as required. The tip tank modification resumed.
